Inspection Report Minerals Regulatory Program Report Date June 7, 2006

Iine Name: Walker Flat Permit number: M0150081

Mine Name: Walker Flat
Operator Name: Miracle Rock Mining and Research

Inspection Date: April 6, 2006

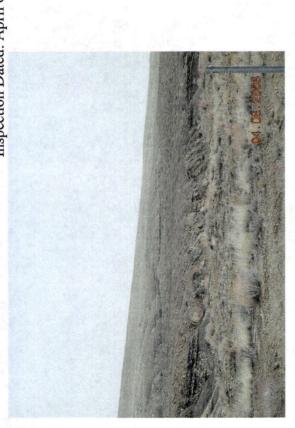
7. Backfilling/Grading (trenches, pits, roads, highwalls, shafts, drill holes)
The site blends well with surrounding areas (Photo 1). One small drainage was blocked, but the

larger drainage running through the site has been cleared. It had been blocked for a time while the operator was mining.

Photo 1. The general area is flat.

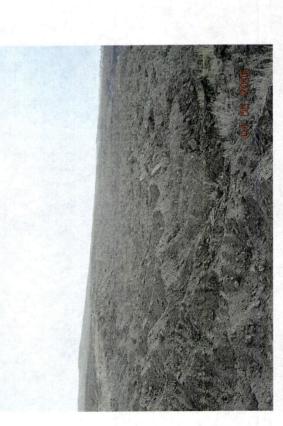
The surface preparation was terrific—couldn't be better (Photos 2-4). I found a lot of seeds in the southern part of the area but didn't see any farther north. Most seeds I found were on the surface, and I am concerned that they had not worked into the soil. This could be because the site was seeded very recently or because the site was not seeded right after the surface was prepared.

Photo 2. The operator roughened the entire reclaimed area.

If the northern part of the area was not seeded, the operator should wait until fall, seed the area, then rake it. Otherwise, the Division and the operator need to simply wait for things to grow.

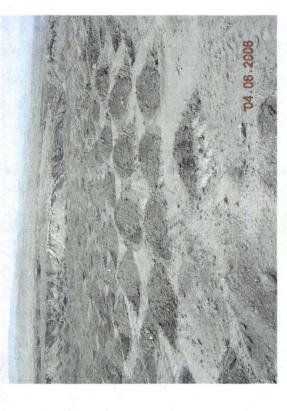
Photo 3. This is in the northern part of the reclaimed area.
